## TEST REPORT

No.: XMIN2607001529CM10\_EN

Sample Name : Bianco Carrara Lo-Si

1. Test Item: Quantitative Analysis of Crystalline Silica

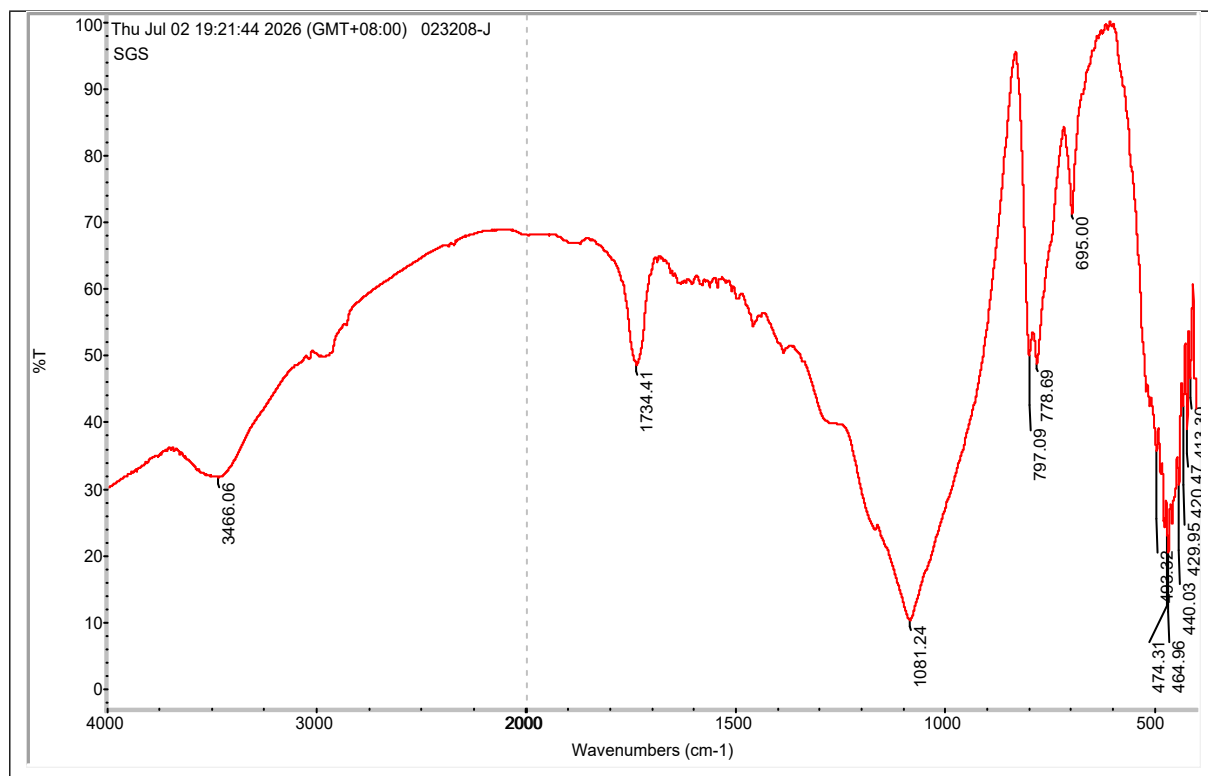
Fig.1: FTIR spectrum of original sample

Fourier Transform Infrared Spectrometer (FTIR)

| Composition | Content, Wt% |
|---|---|
| Crystalline Silica | 27.41 |

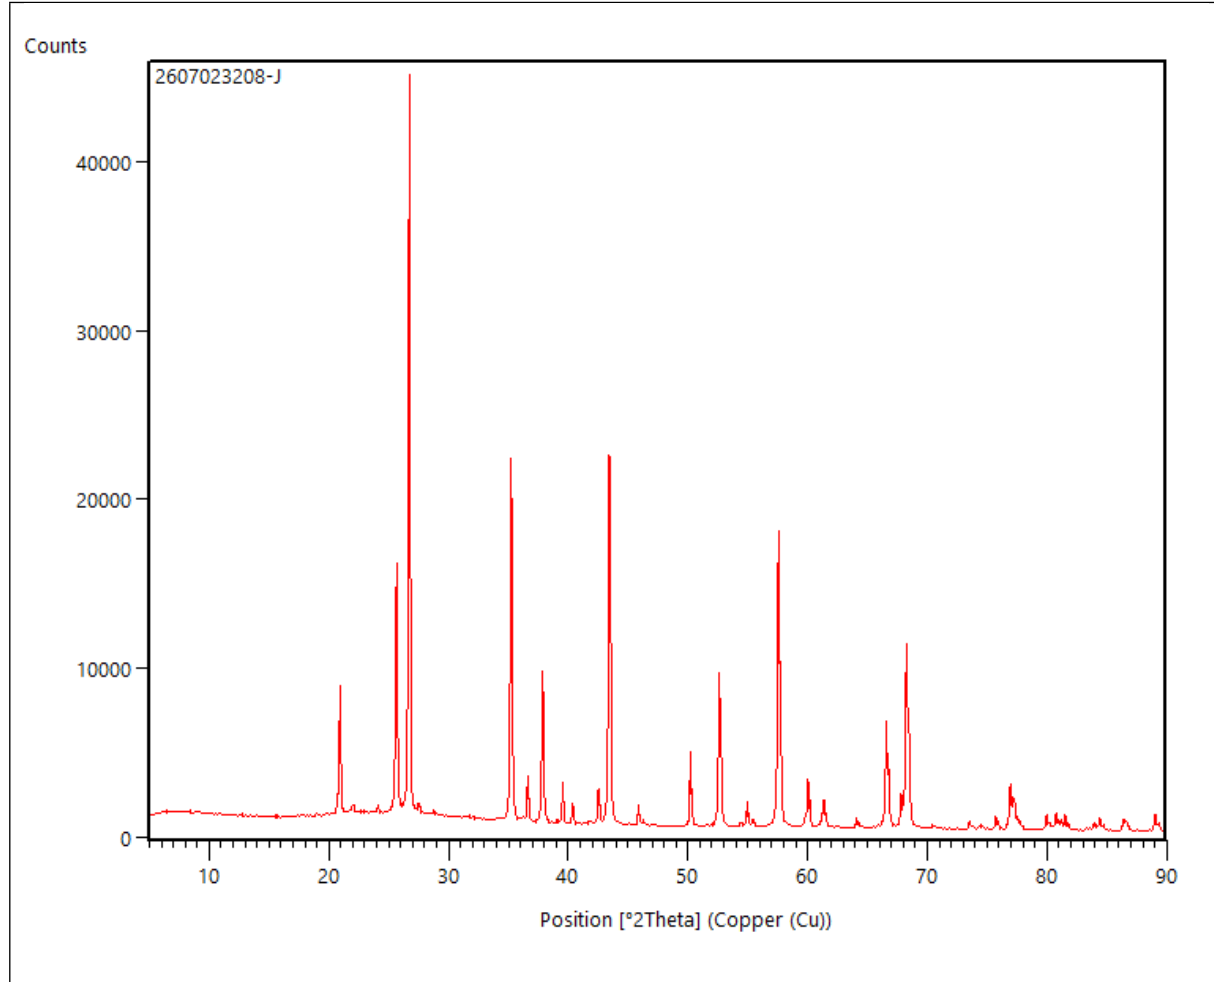
Fig.2: XRD spectrum

X-Ray Diffraction (XRD)

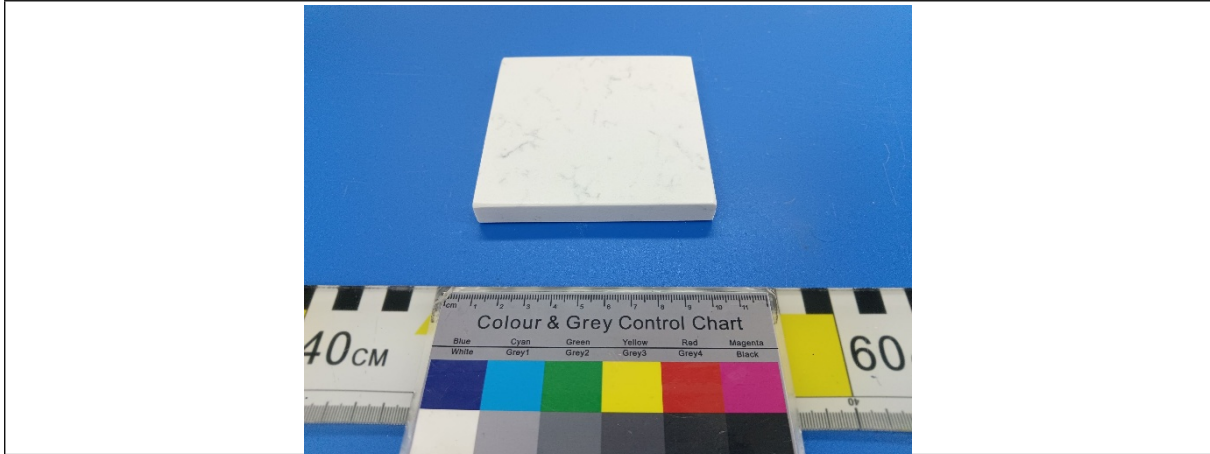
Original Sample-Sample J

Sample Description: See photo
