## TEST REPORT

No.: XMIN2607001529CM13\_EN

Sample Name : Calacatta Bali Lo-Si

1. Test Item: Quantitative Analysis of Crystalline Silica

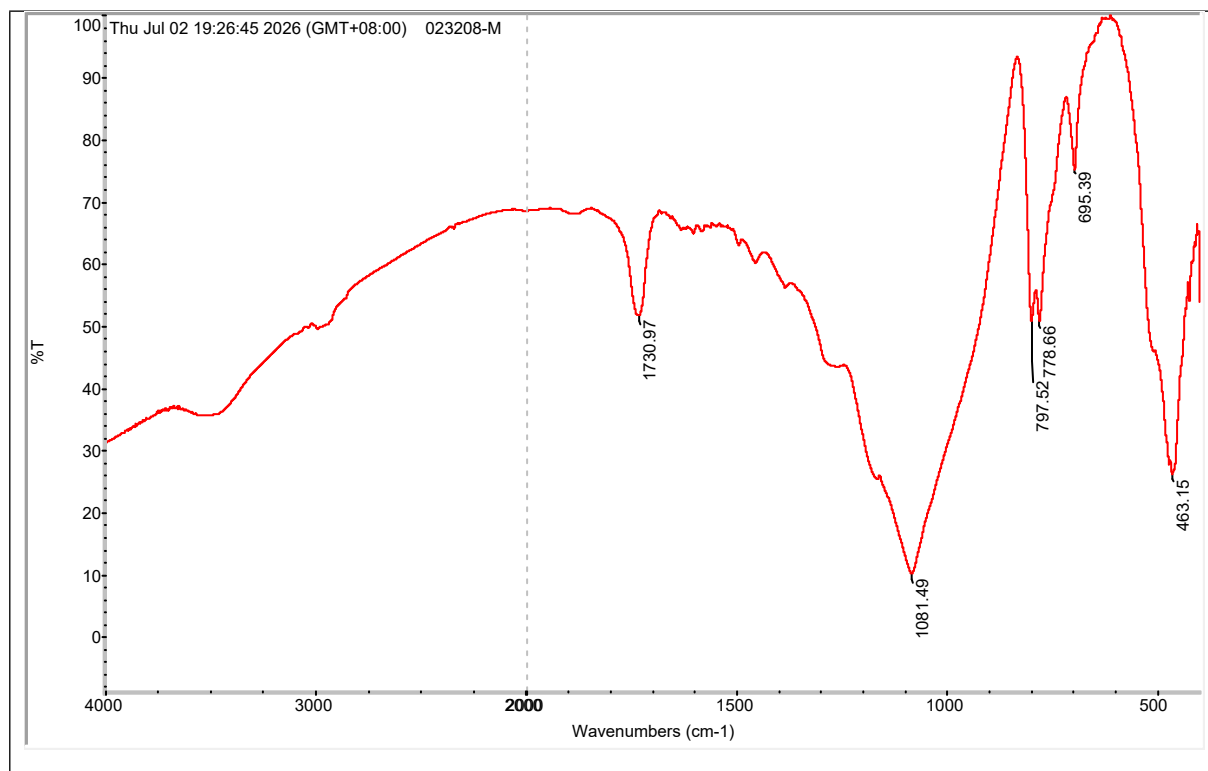
Fig.1: FTIR spectrum of original sample

Fourier Transform Infrared Spectrometer (FTIR)

| Composition | Content, Wt% |
|---|---|
| Crystalline Silica | 27.99 |

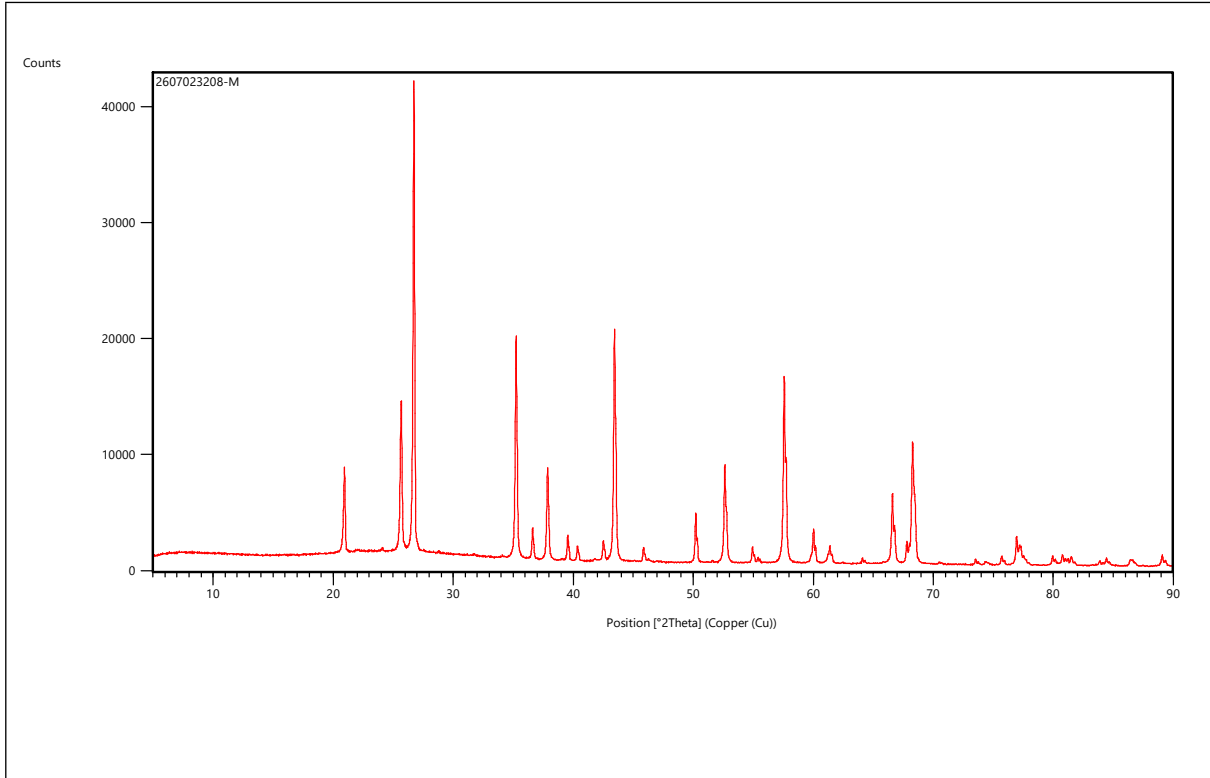
Fig.2: XRD spectrum

X-Ray Diffraction (XRD)

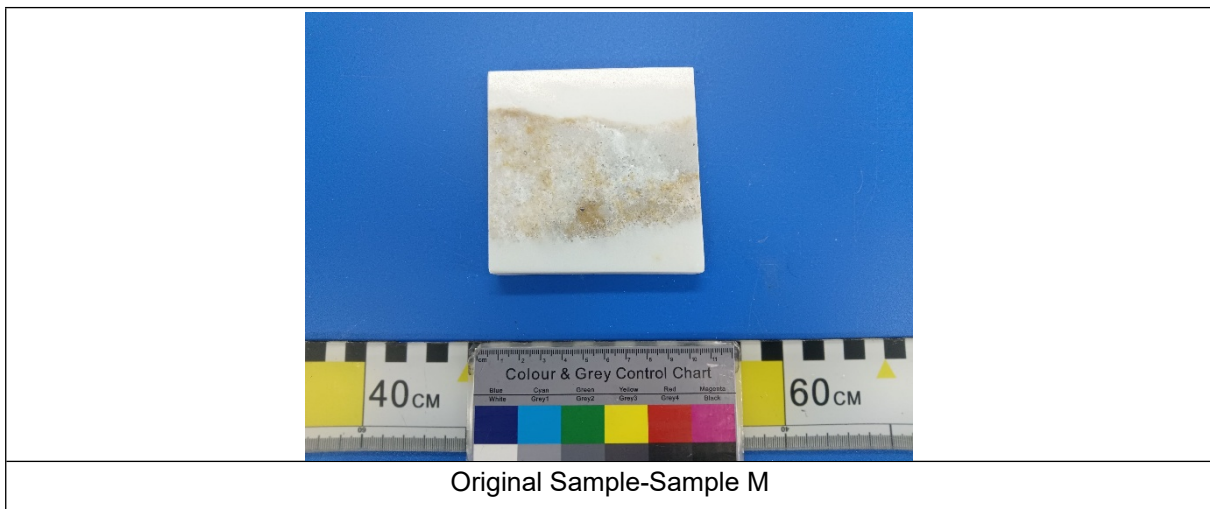
Original Sample-Sample M

Sample Description: See photo
