## TEST REPORT

No.: XMIN2607001529CM21\_EN

Sample Name : Cortina Lo-Si

1. Test Item: Quantitative Analysis of Crystalline Silica

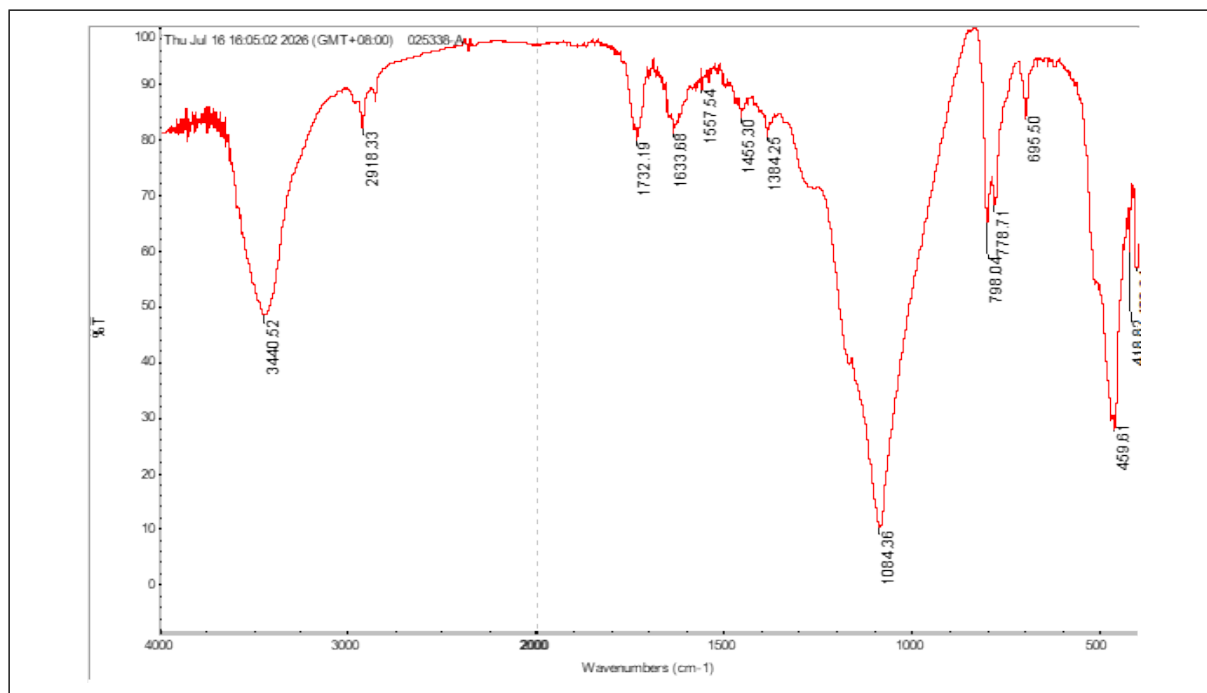
Fig.1: FTIR spectrum of original sample

Fourier Transform Infrared Spectrometer (FTIR)

| Test Item | Test Result |
|---|---|
| Crystalline Silica, % | 28.59 |

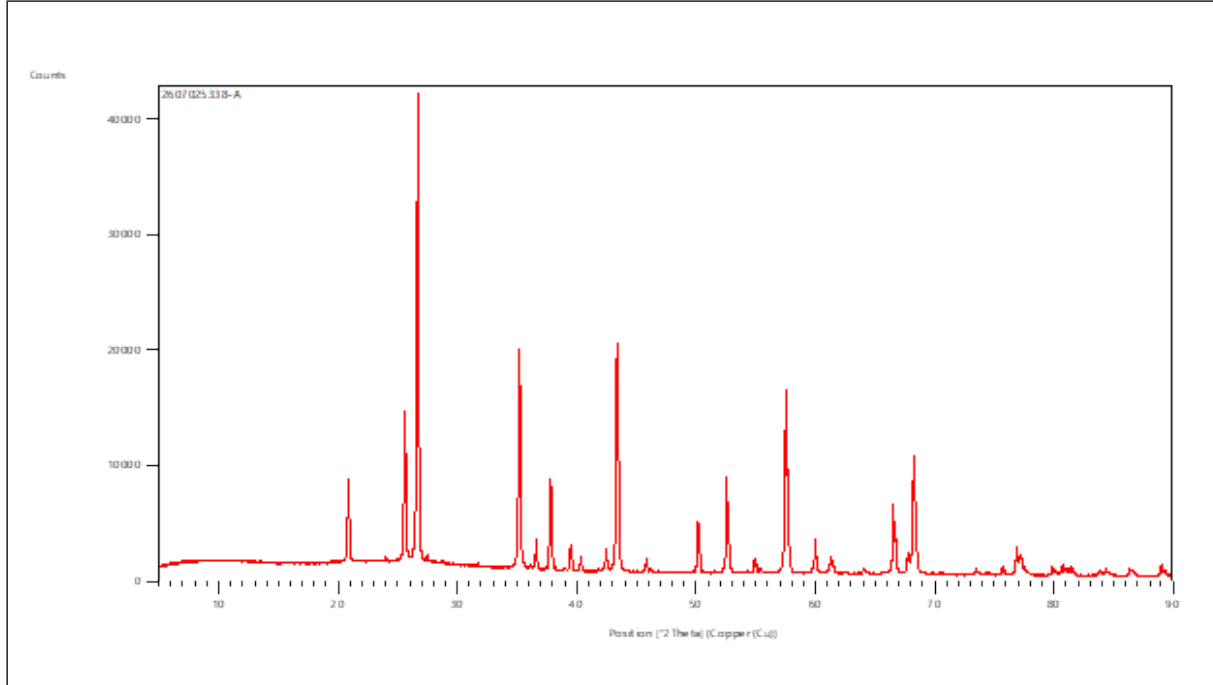
Fig.2- XRD spectrum

X-ray Diffractometer (XRD)
